Hydrochloric Acid Bund

Gold Mine
Queensland

We were asked to provide a solution to repair damaged concrete and coat to protect bund from future acid attack.

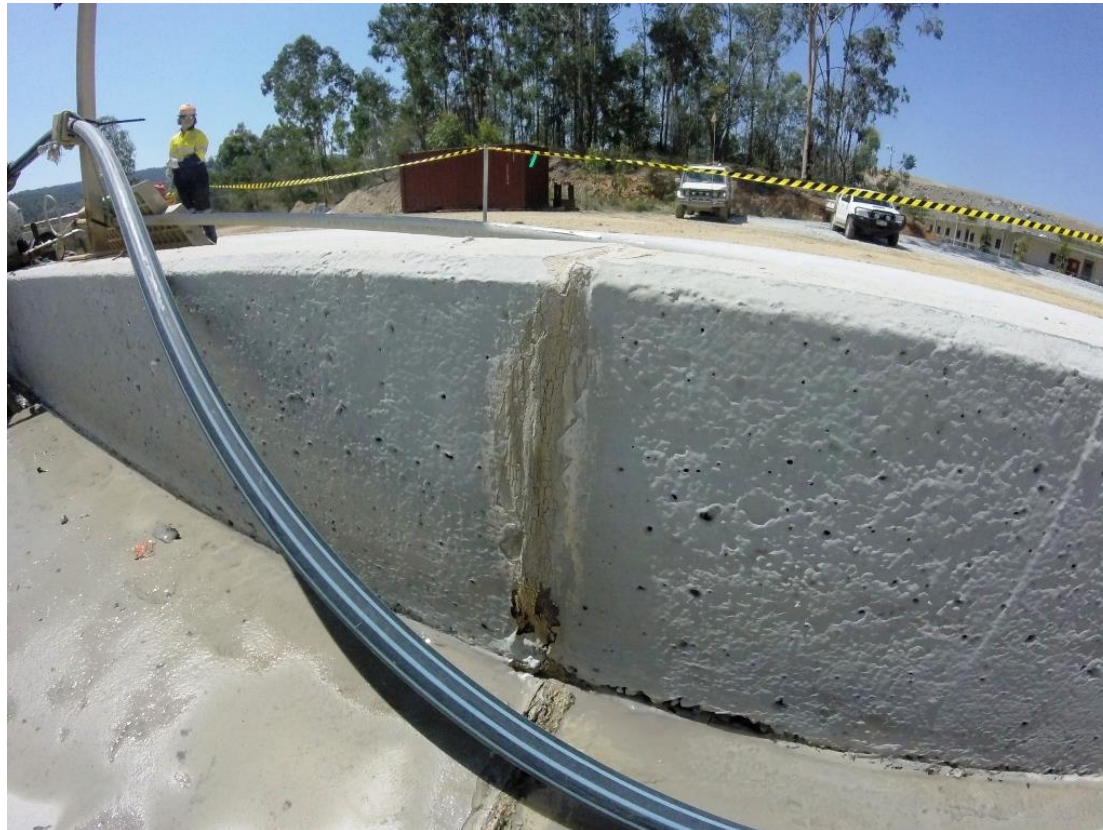
Previous Unknown coating had failed, Acid attack and damage apparent.

Coating and Bund Damage

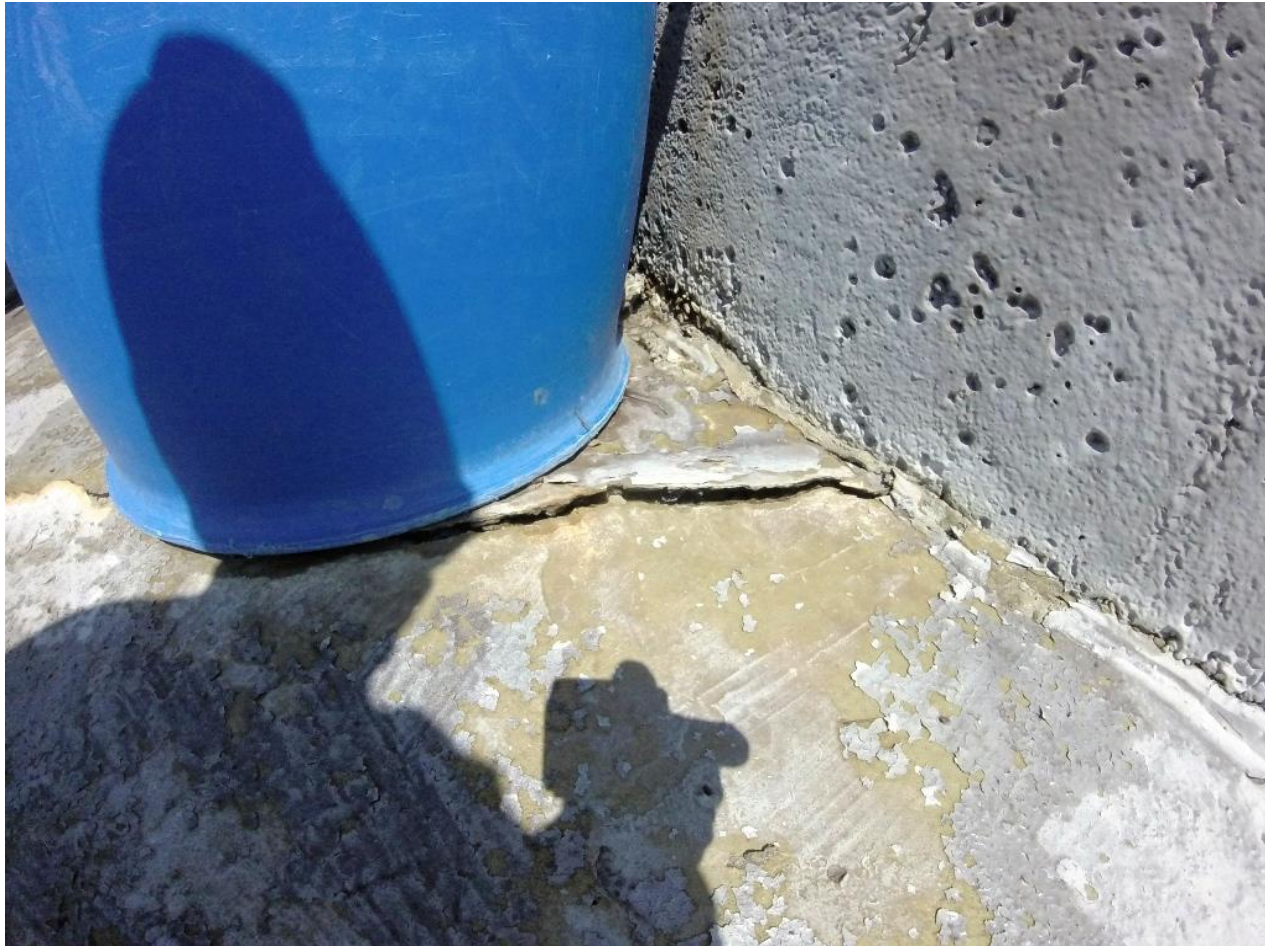
Control Joints in need of rectification.

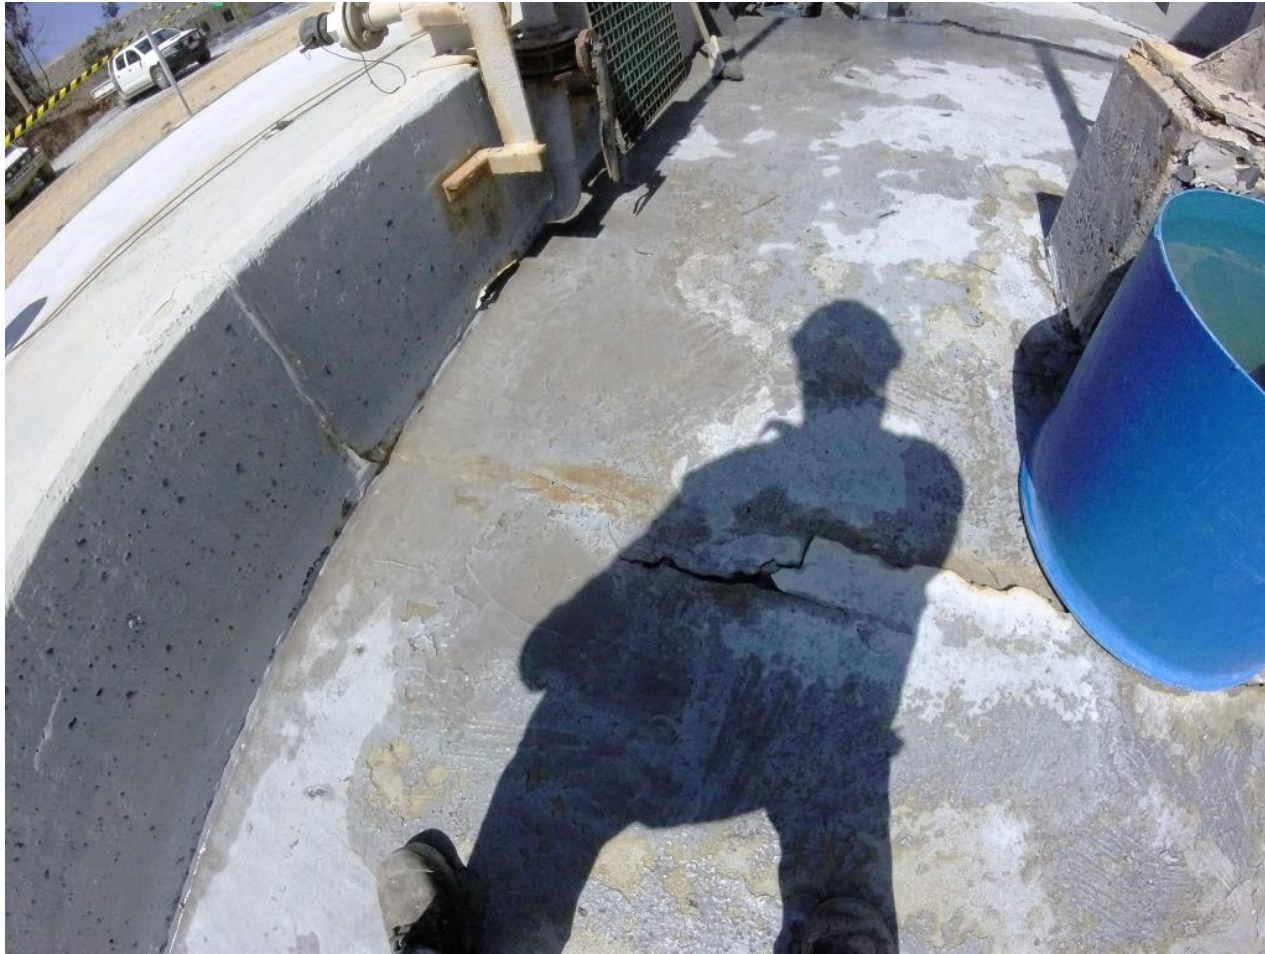
Plinths needing repair

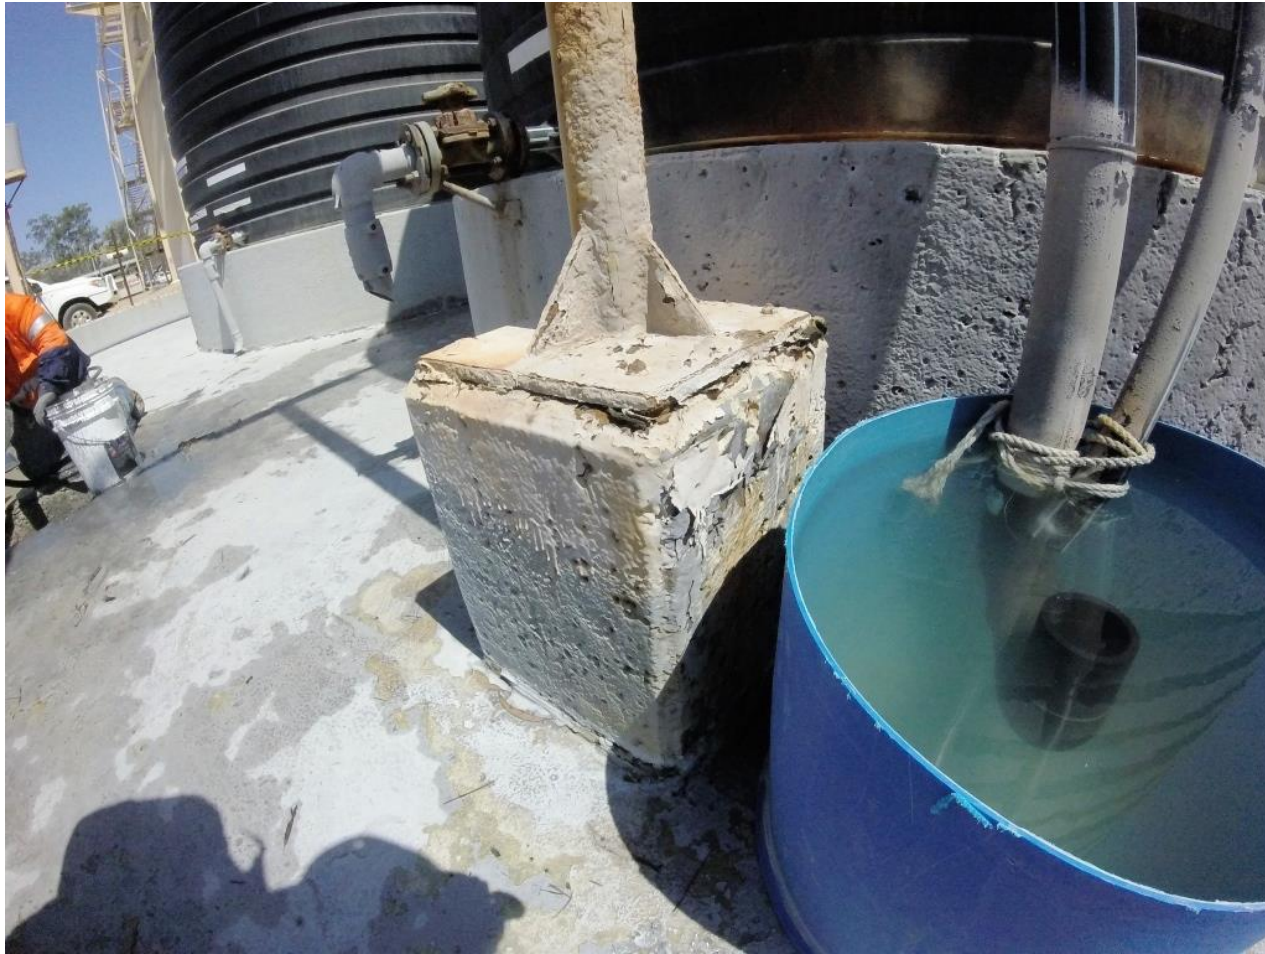
Sumps needing repair

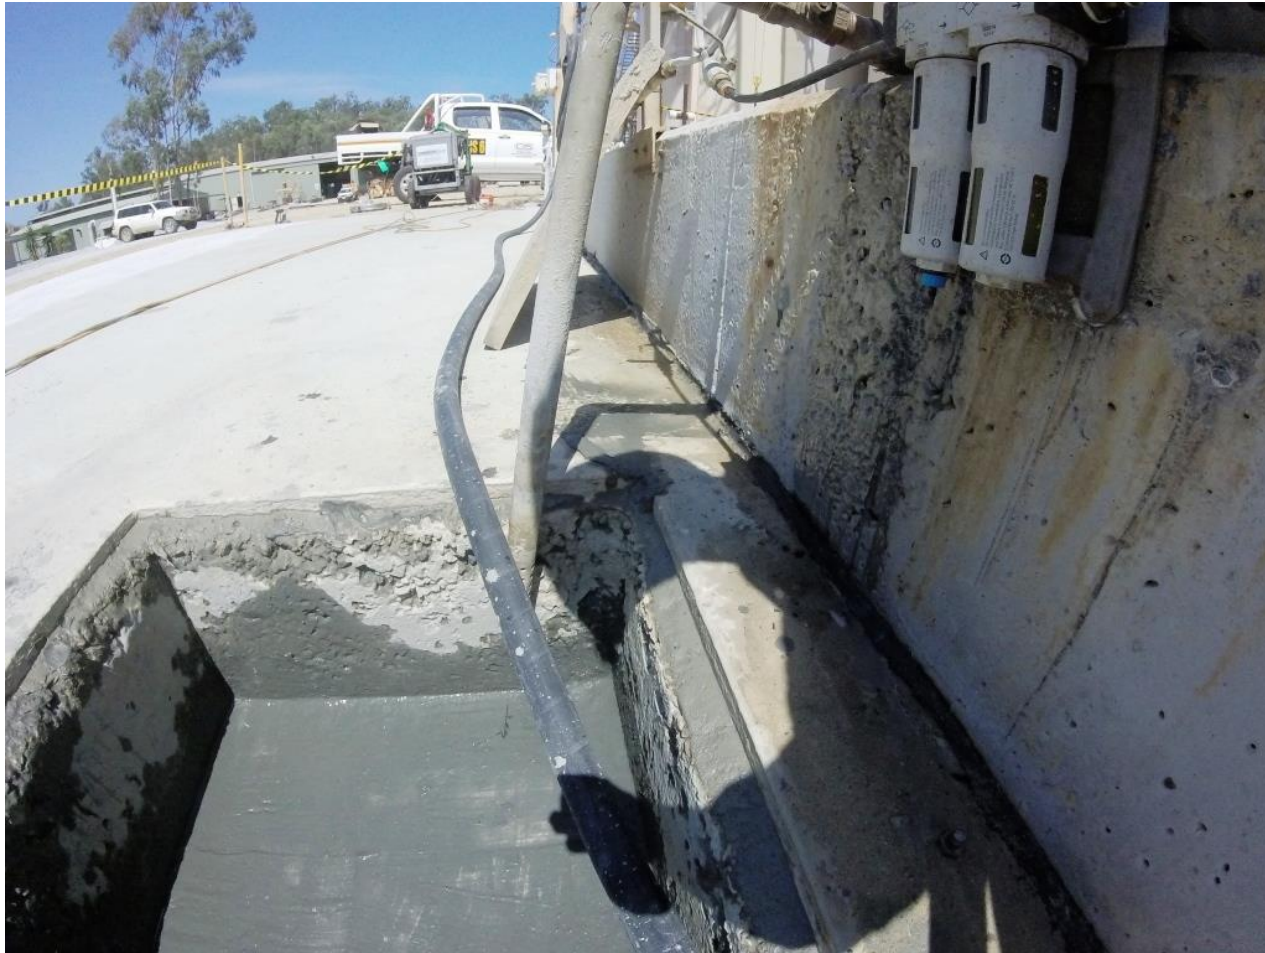
Seal Between Tank and Tank Base needing repair

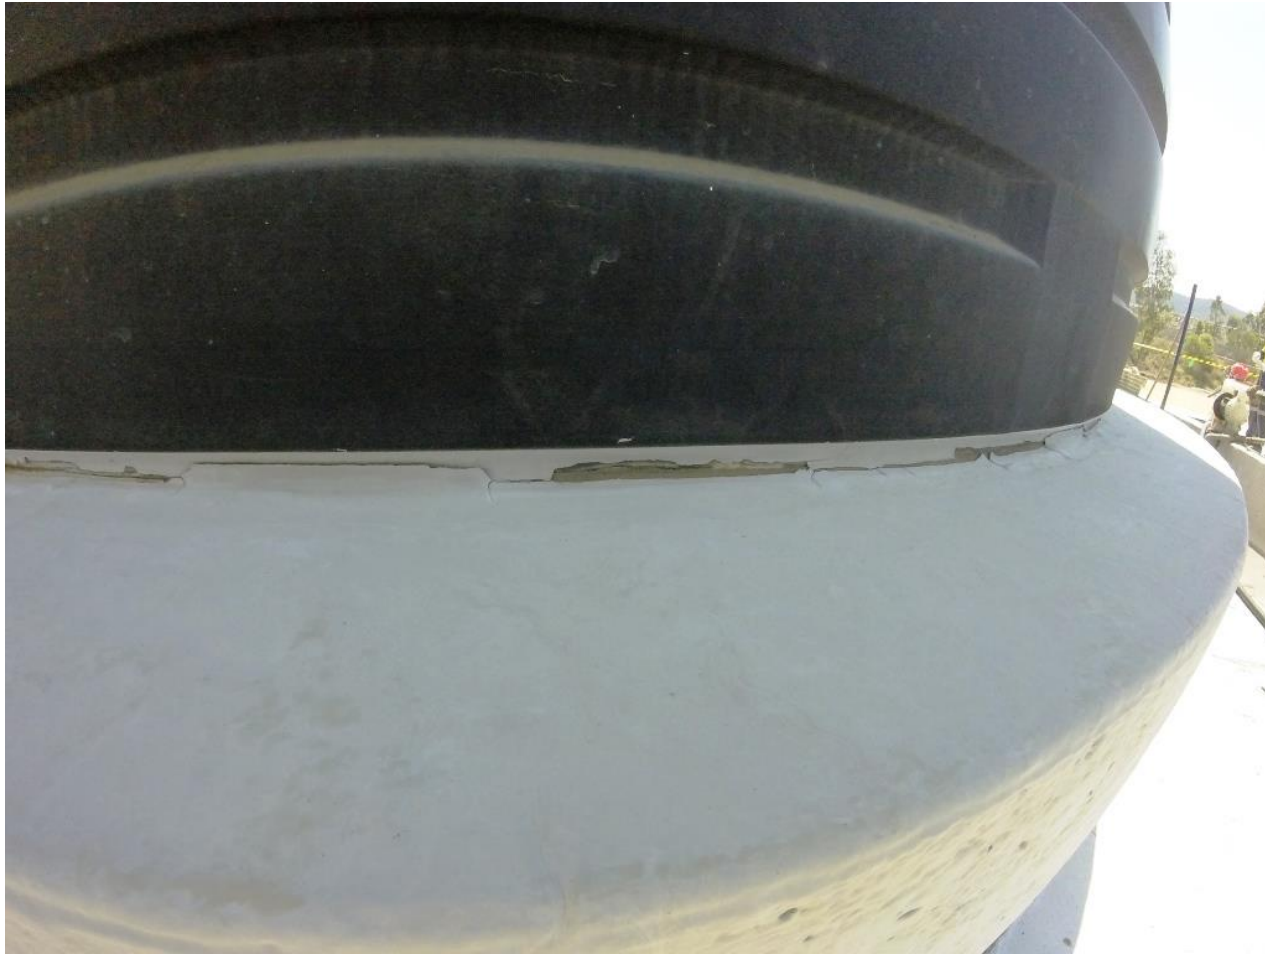
Seal between base and floor needing repair

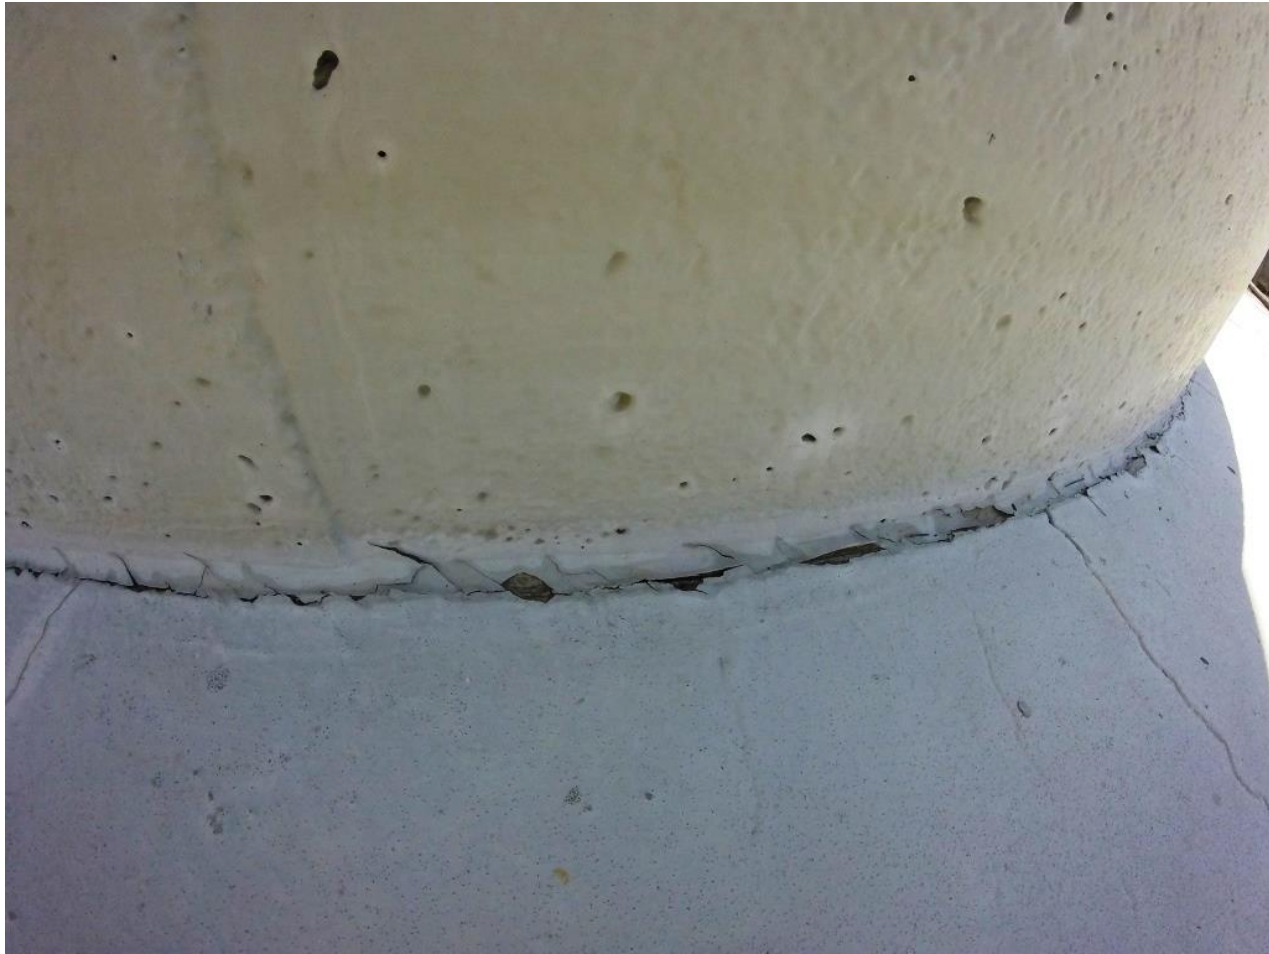
Damaged control joints

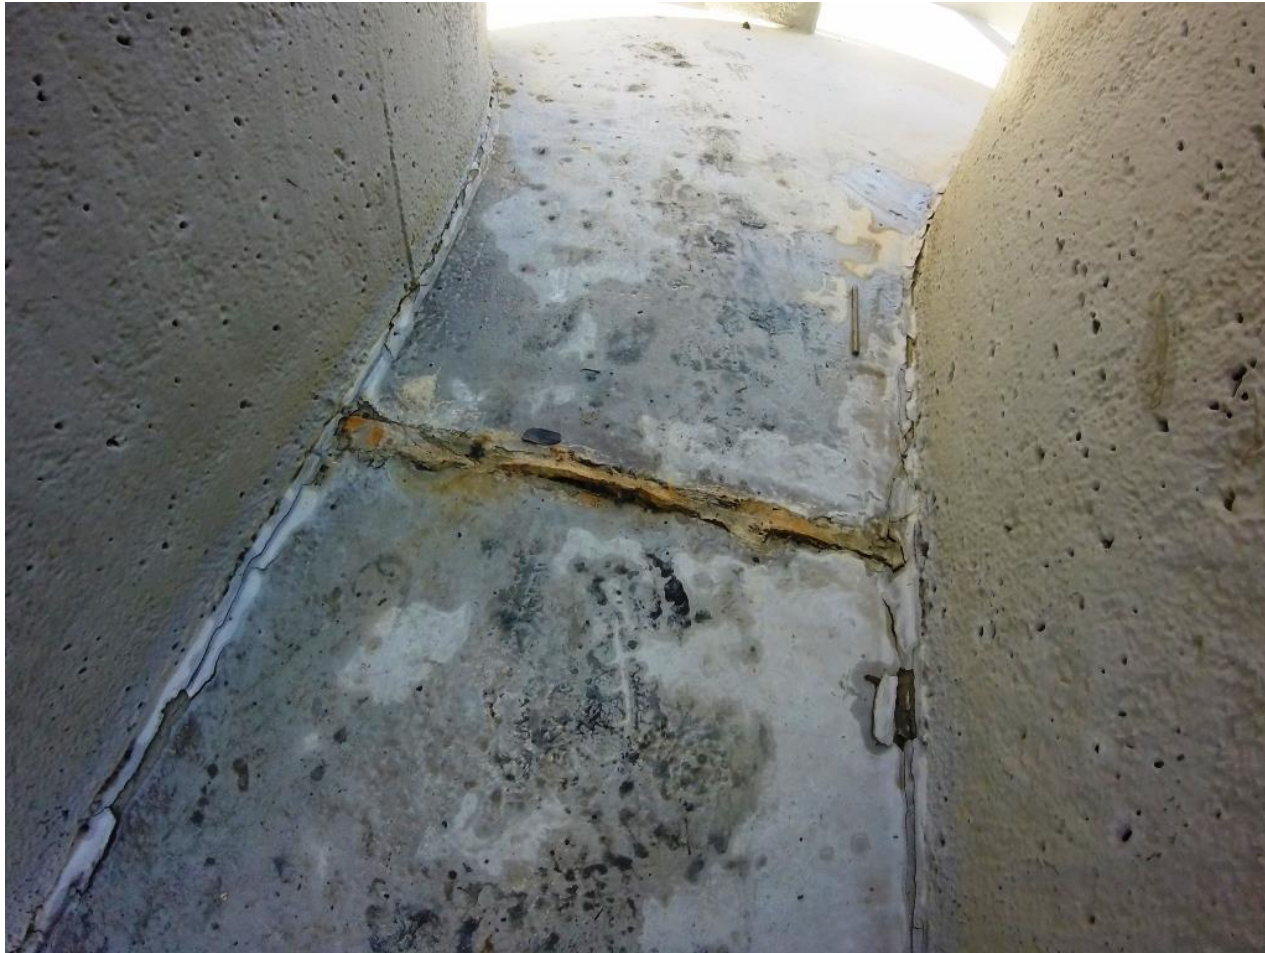
Sump needing rectification

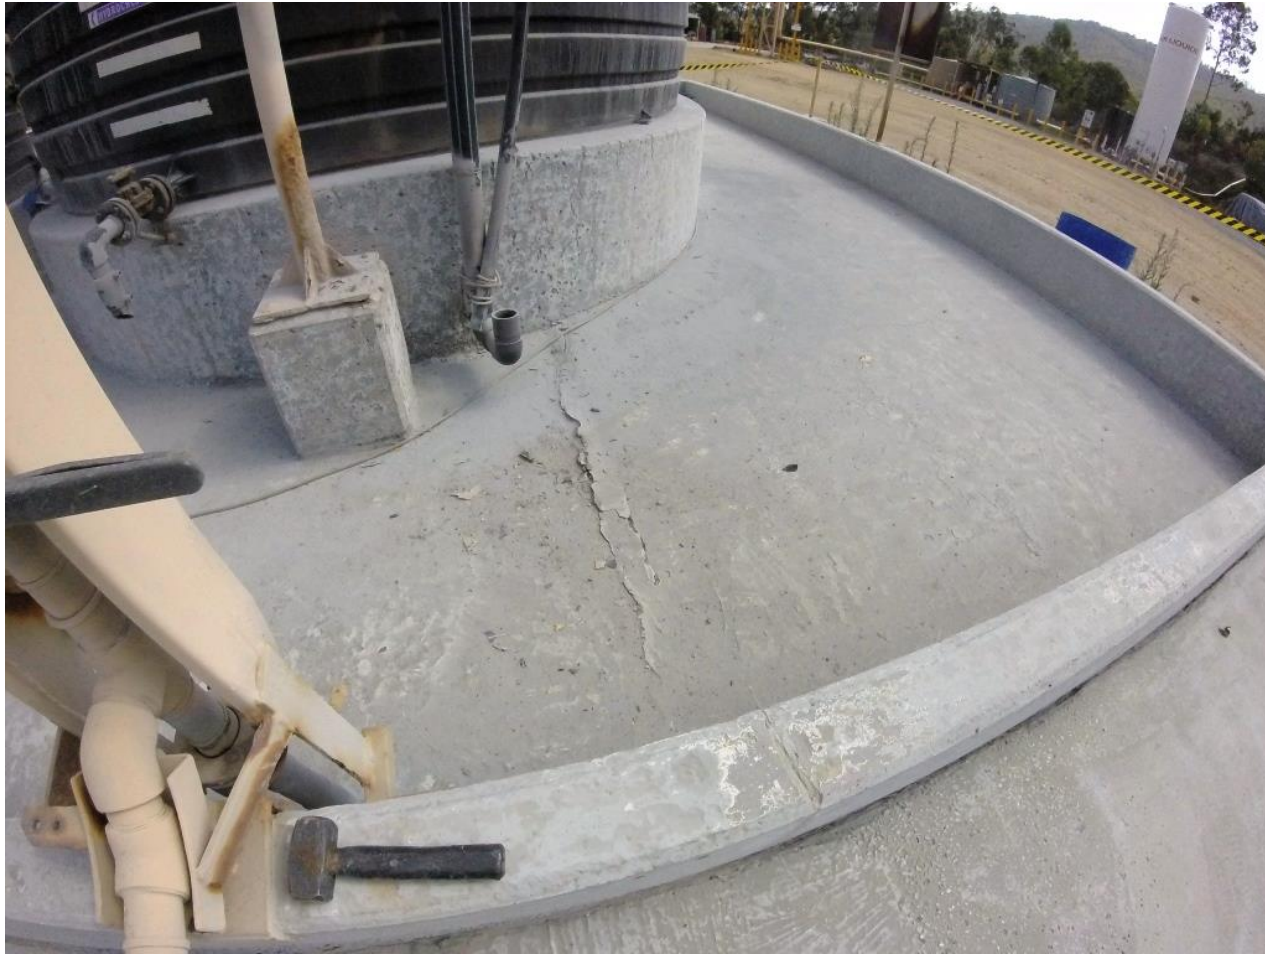
Damaged areas removed
