# August 2016 works SS pipe & Crane base

By ENECON Mesogios Ltd

Nicosia, August 2016

Waste Water Treatment plant

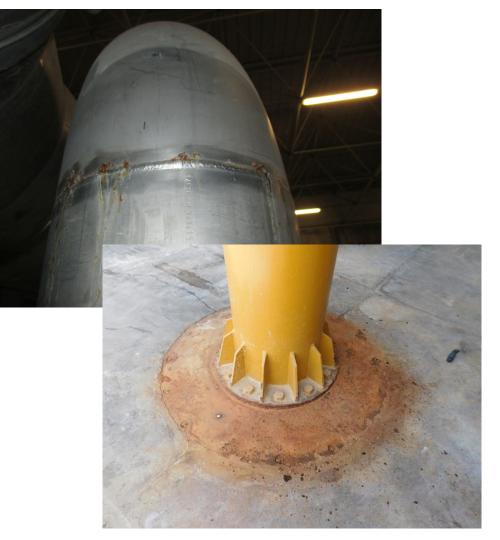
# **Corroded base of crane**

The reason the base was consistently getting corroded was due to the fact that water was reaching the metal part.

- Clean up loose material and rust as well as old paint as much as possible
- Rebuild surrounding area with DuraFill mixed with highly rated silica sand.
- Coat all twice with CHEMCLAD
   SC

Rebuilding with a material that bonds to metal from one end and finishing to zero point.
