Cyprus Biological
station

Impeller full overhaul

Biological Treatment plant

Useless damaged valve

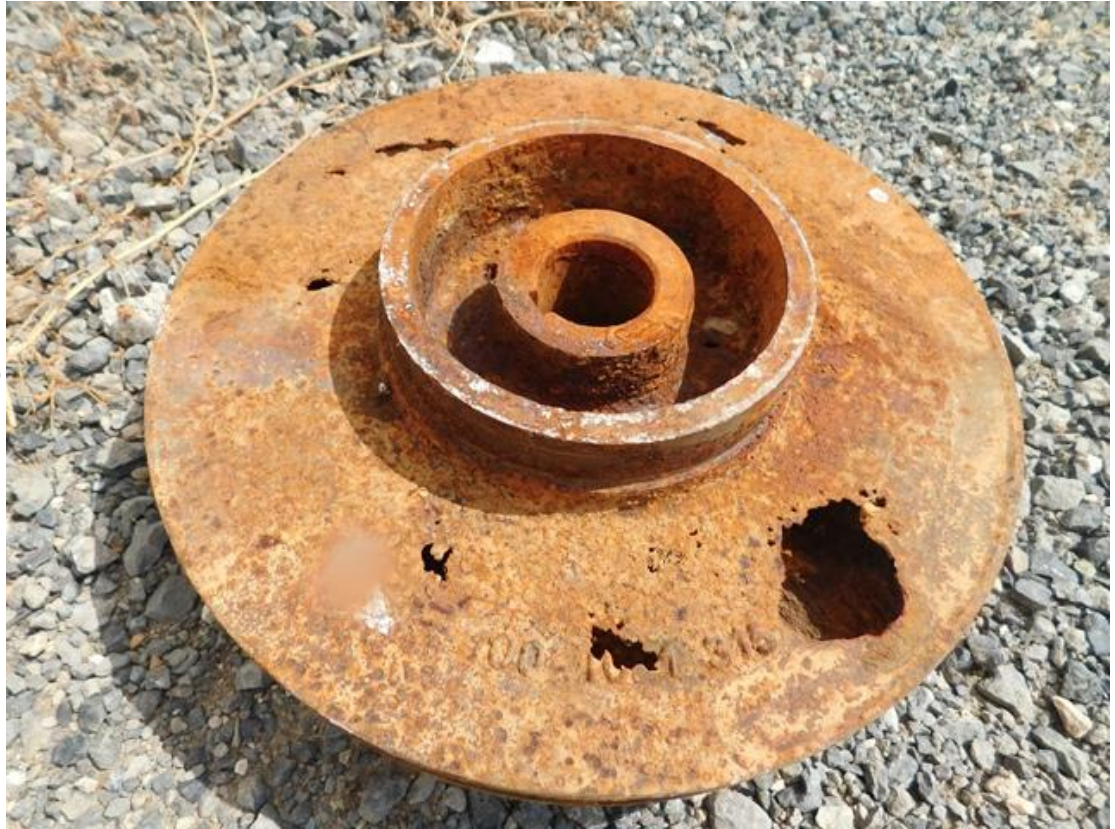
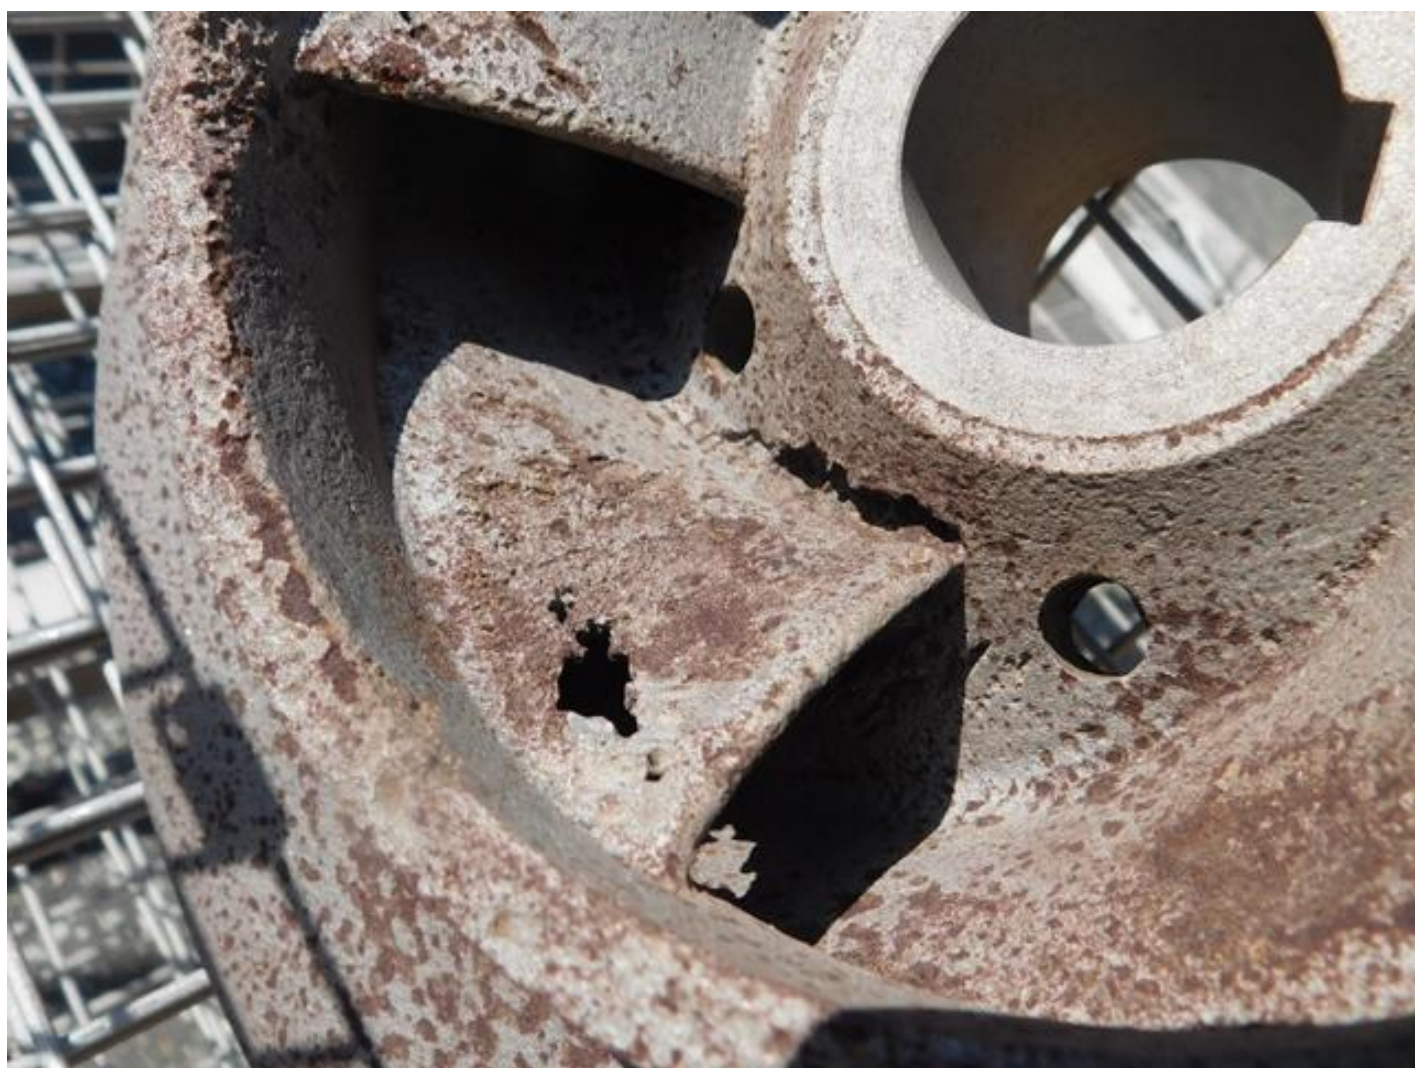
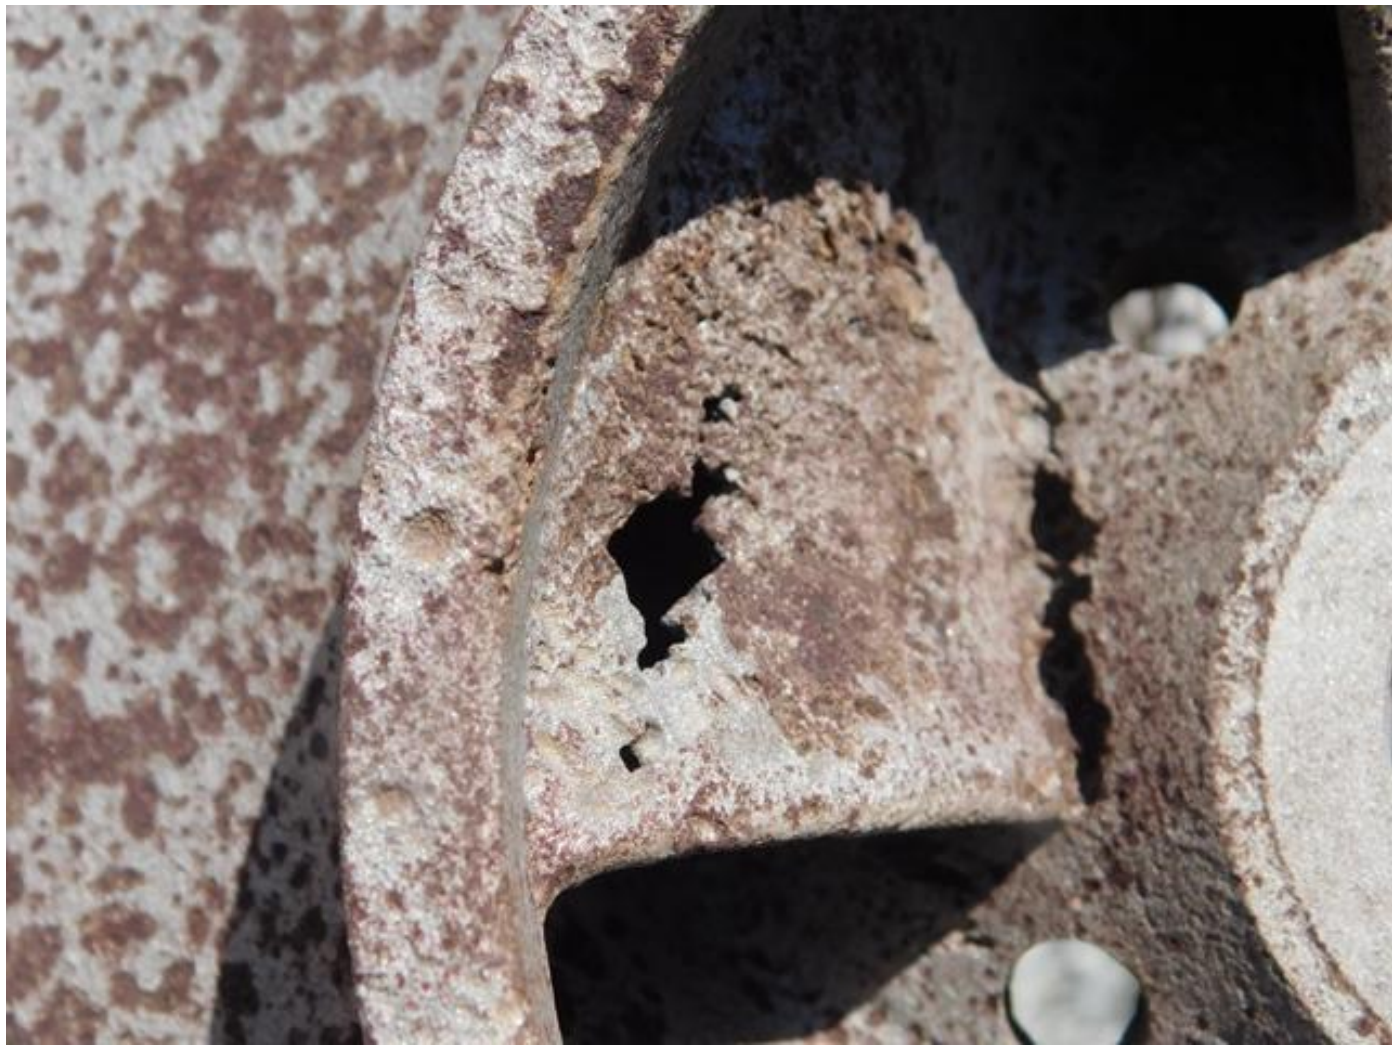
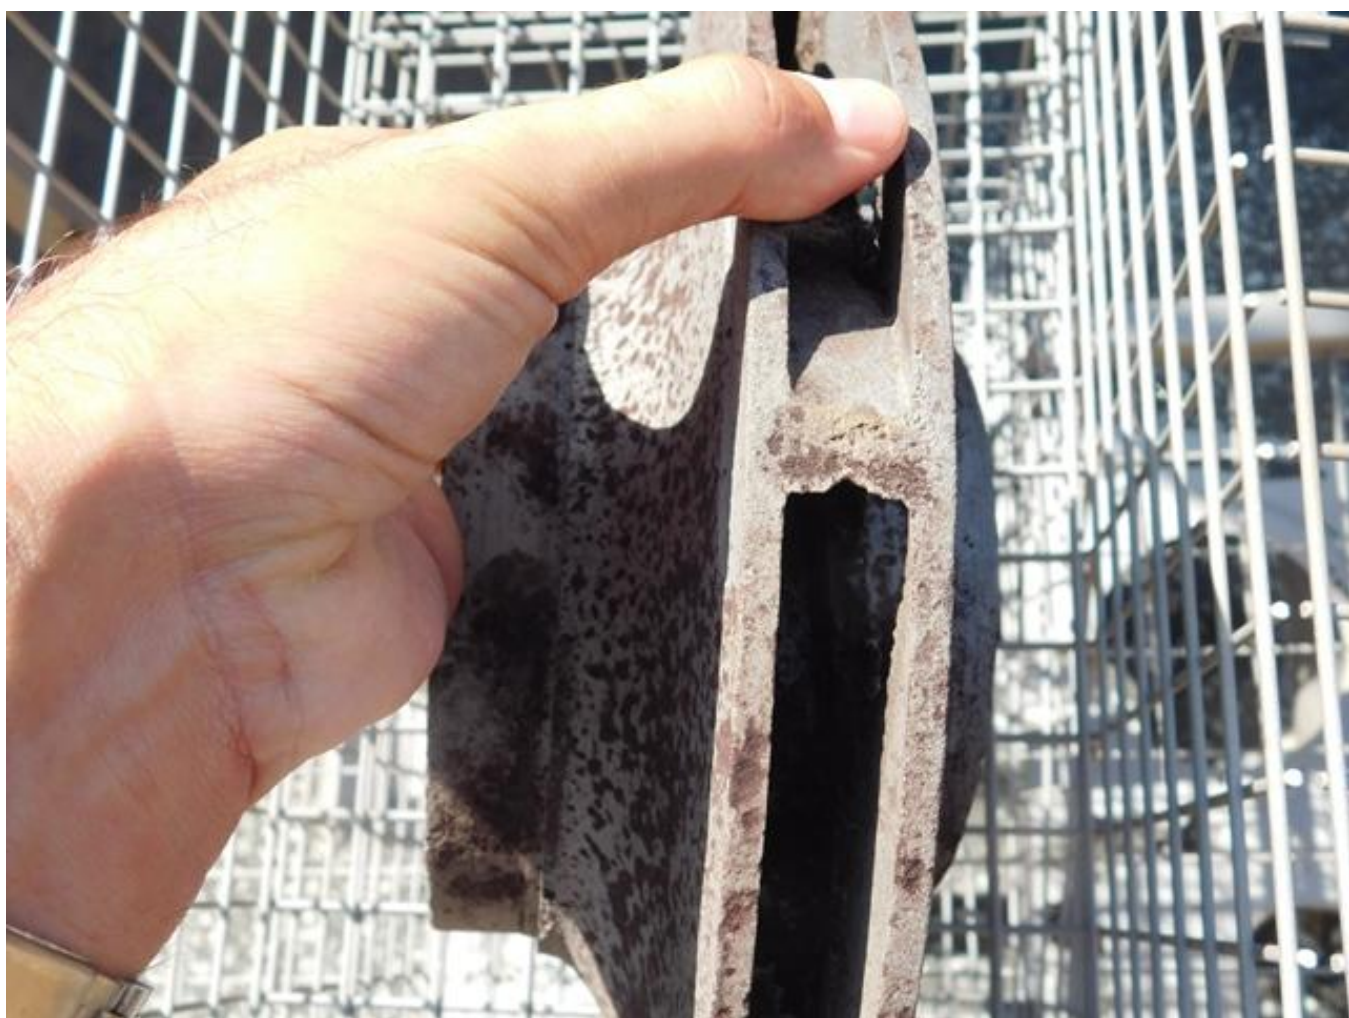
The problem Valve was not operational due to extended damage

Grit blast

Rebuild with ENECON's DurAlloy

Coat & Protect with CeramAlloy CL+AC twice

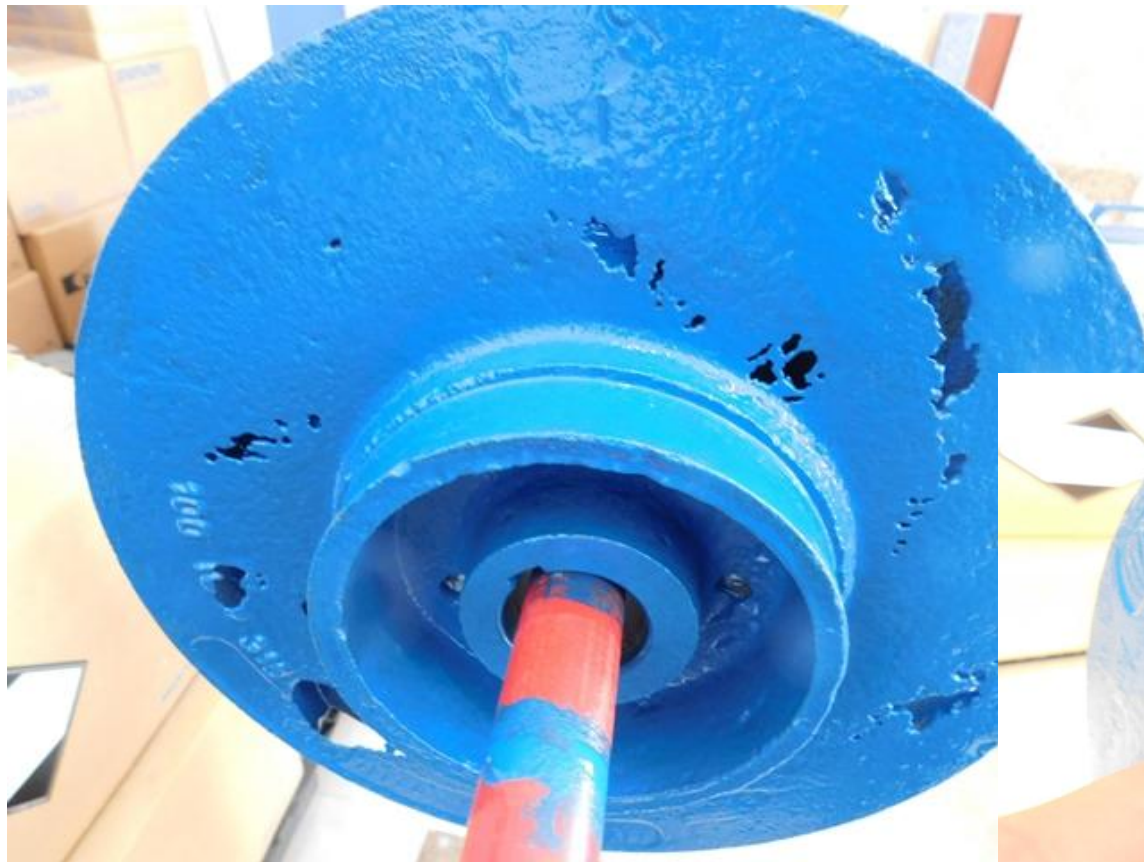
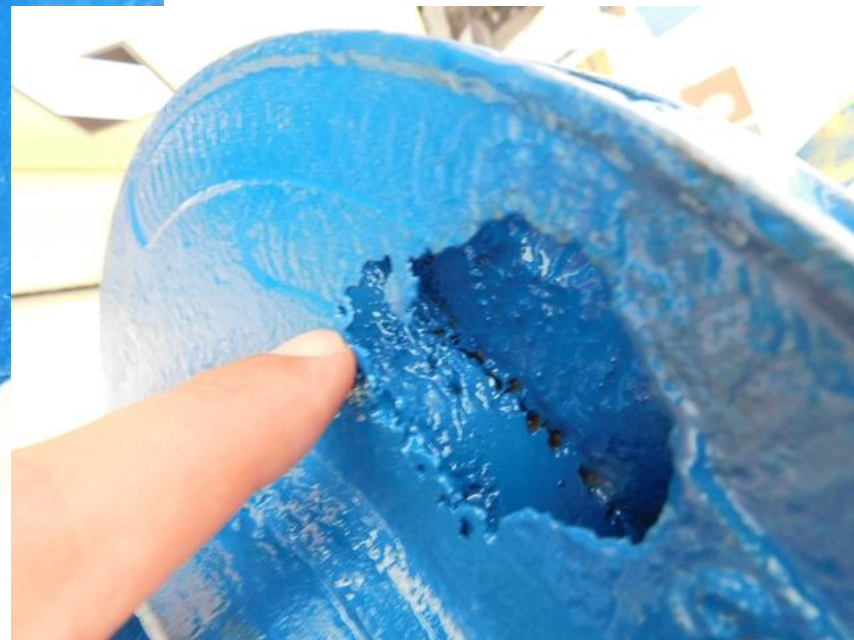
After grit blasting, primed with
CL+AC to reveal the damage...

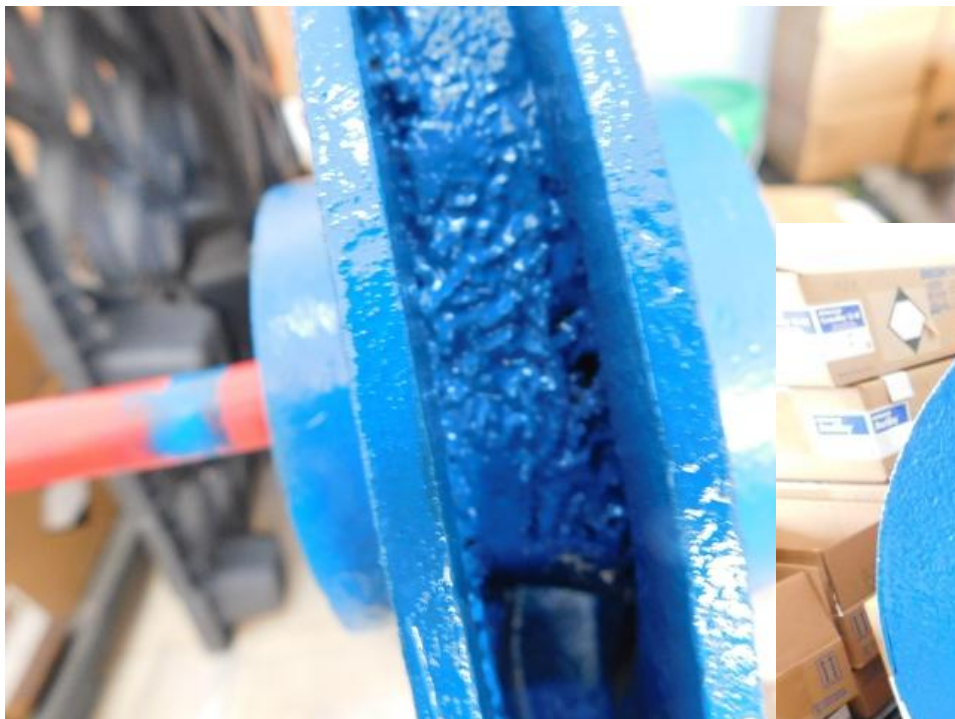
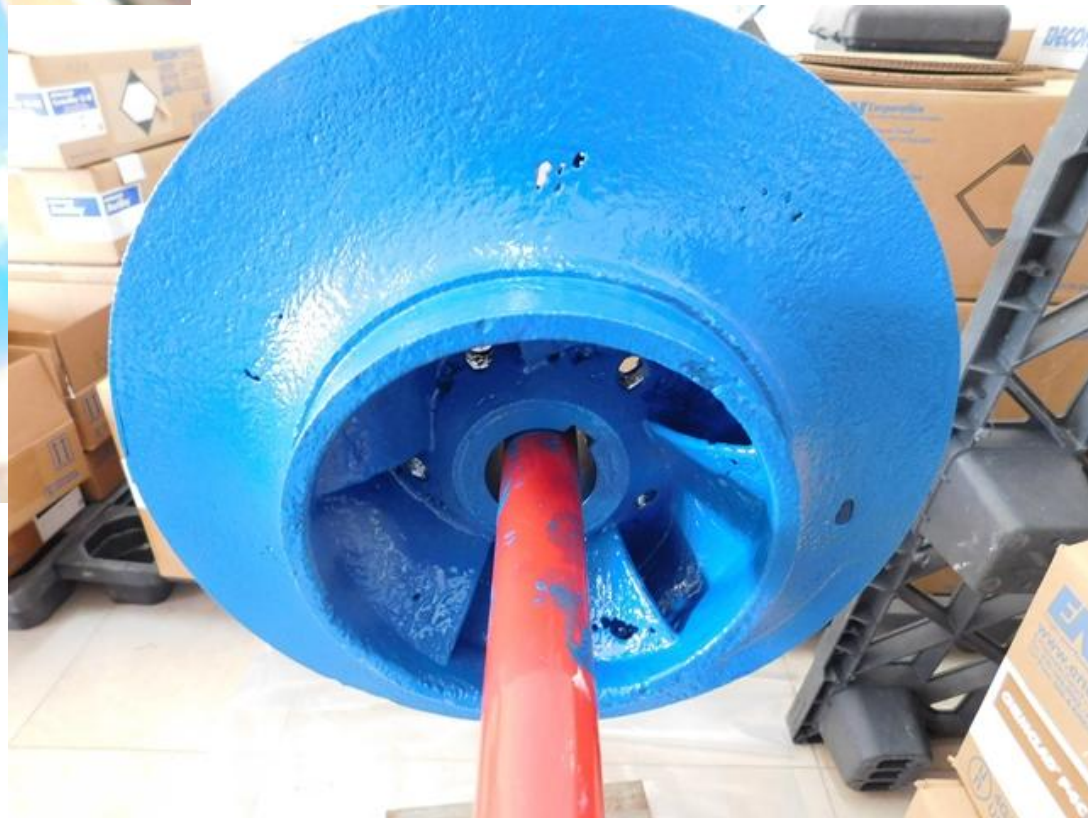
After grit blasting, primed with
CL+AC to reveal the damage...

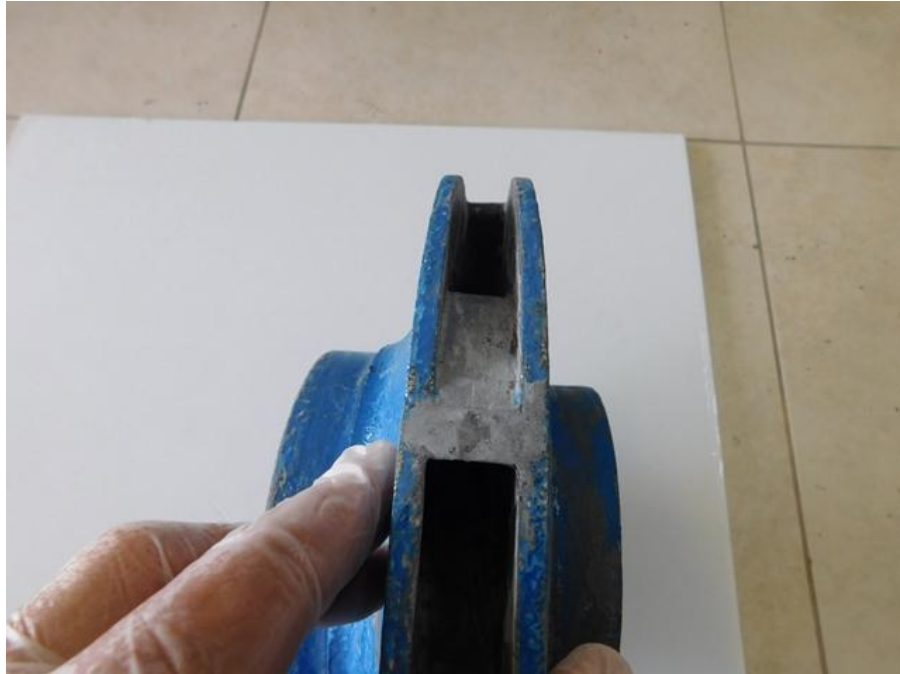
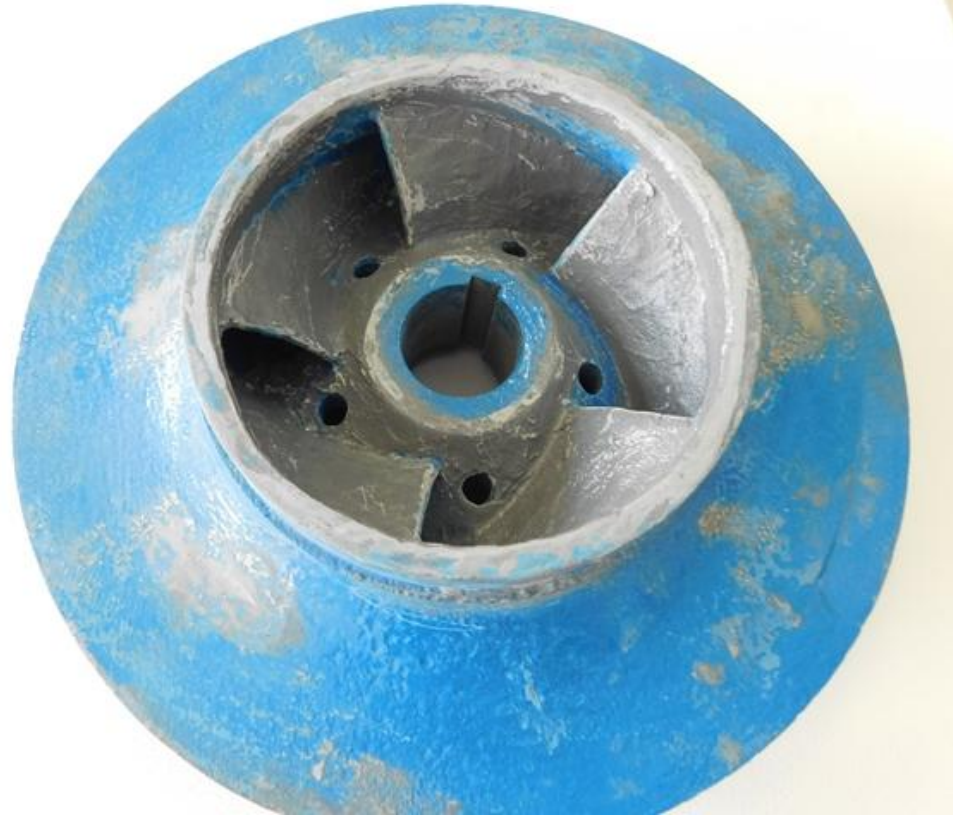
First coat with CeramAlloy CL+AC

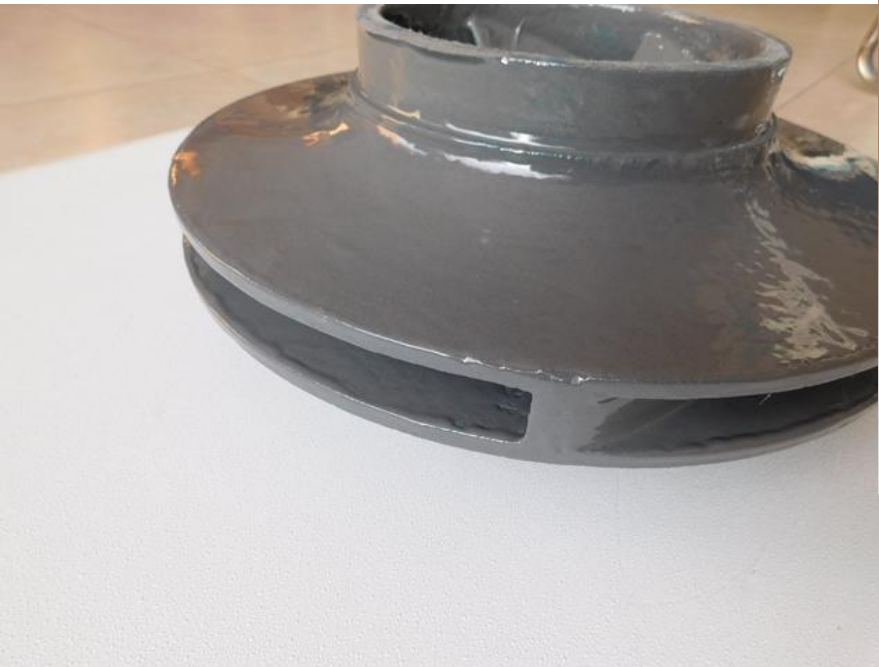
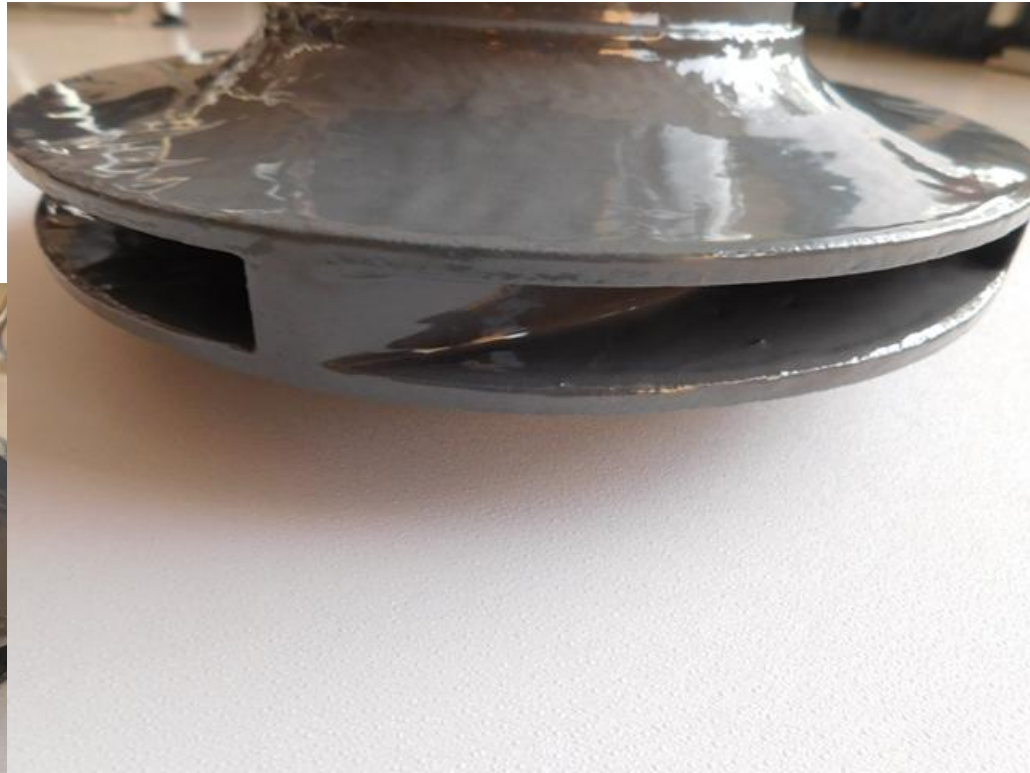
Second and final coat with CeramAlloy
CL+AC with rebuilding in progress
