Larnaca Airport  
Rain-water pumping  
station

Check valve repair

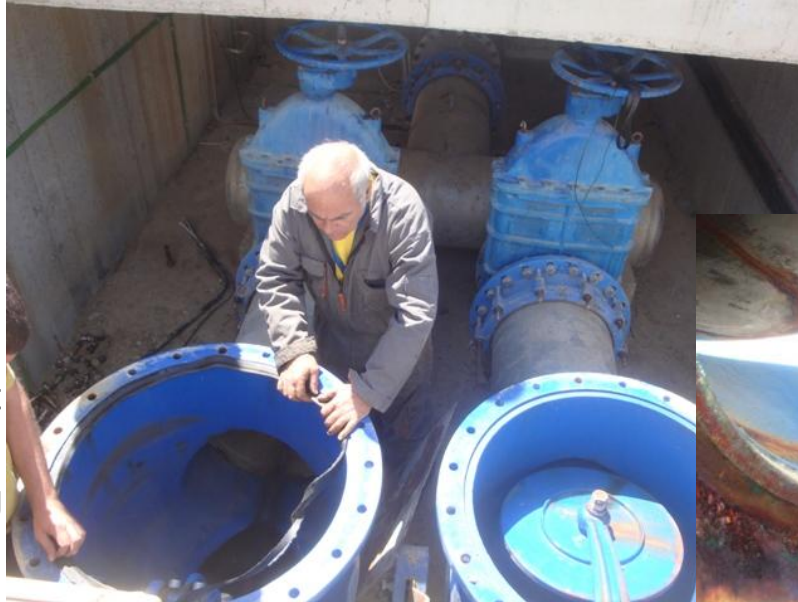
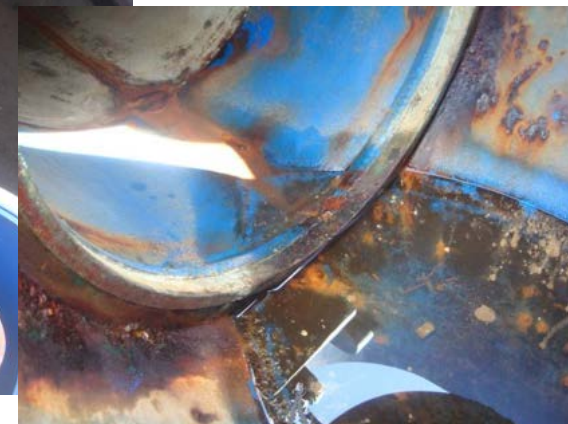
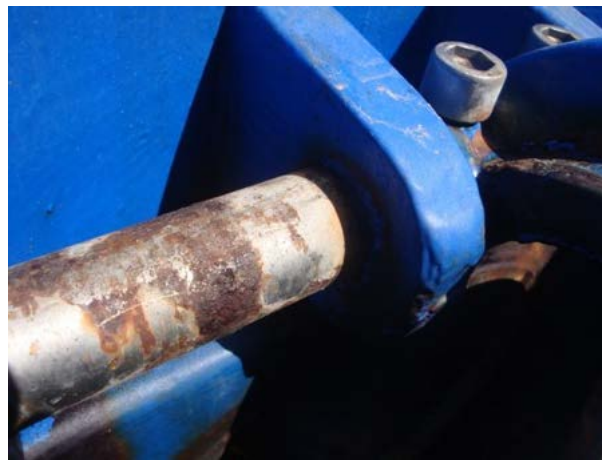
Corrosion on main body and shaft

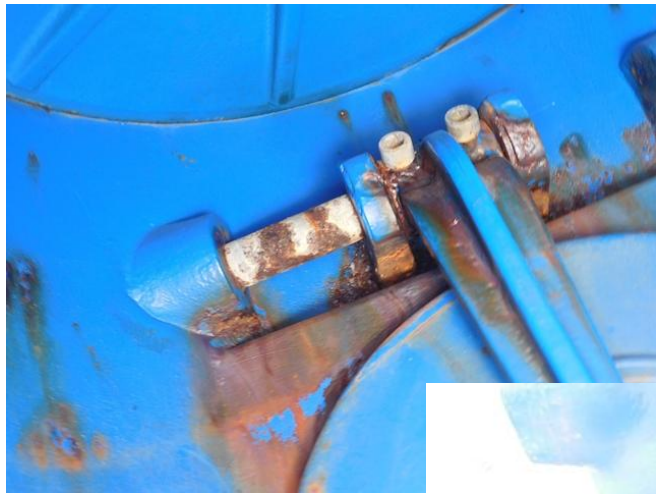
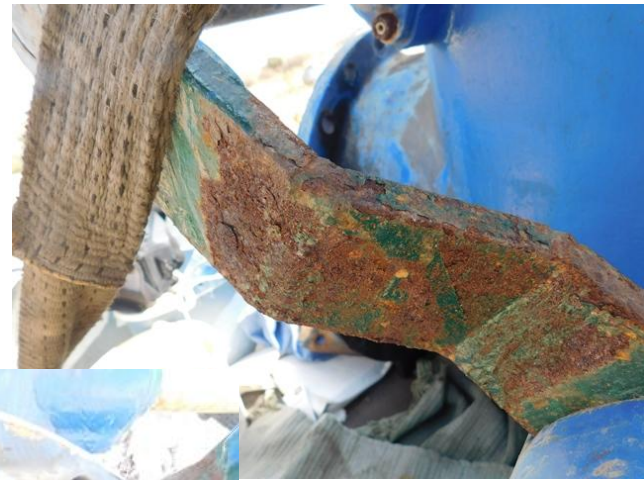
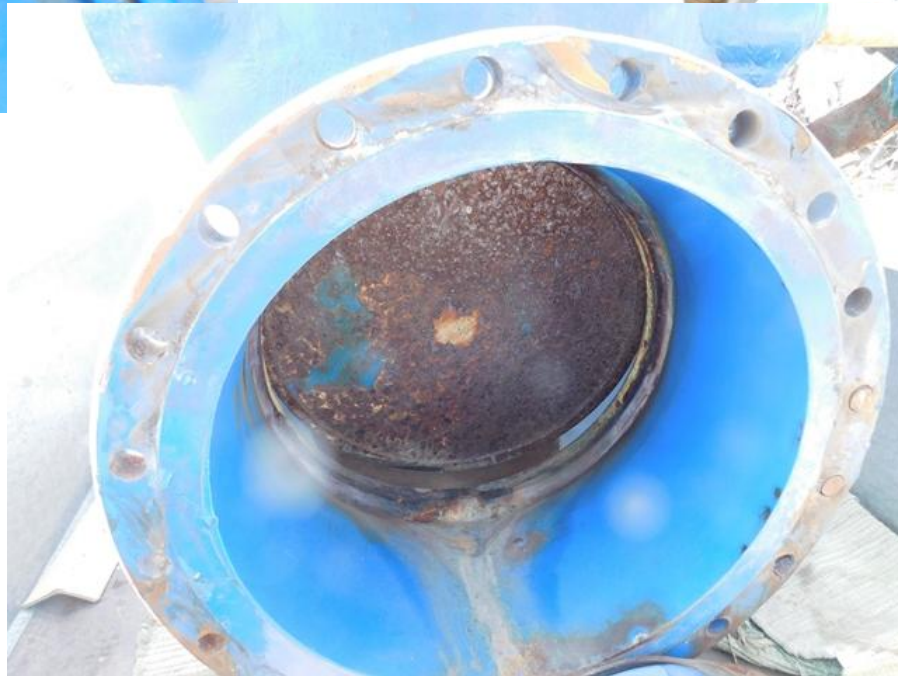
Imperfections on body were repaired  
with **DurAlloy**

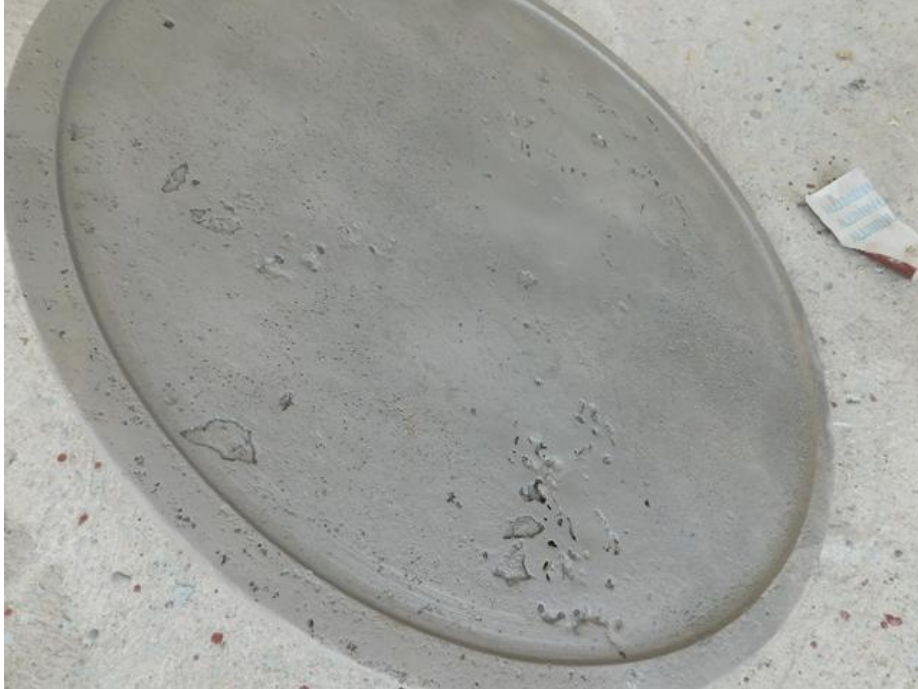
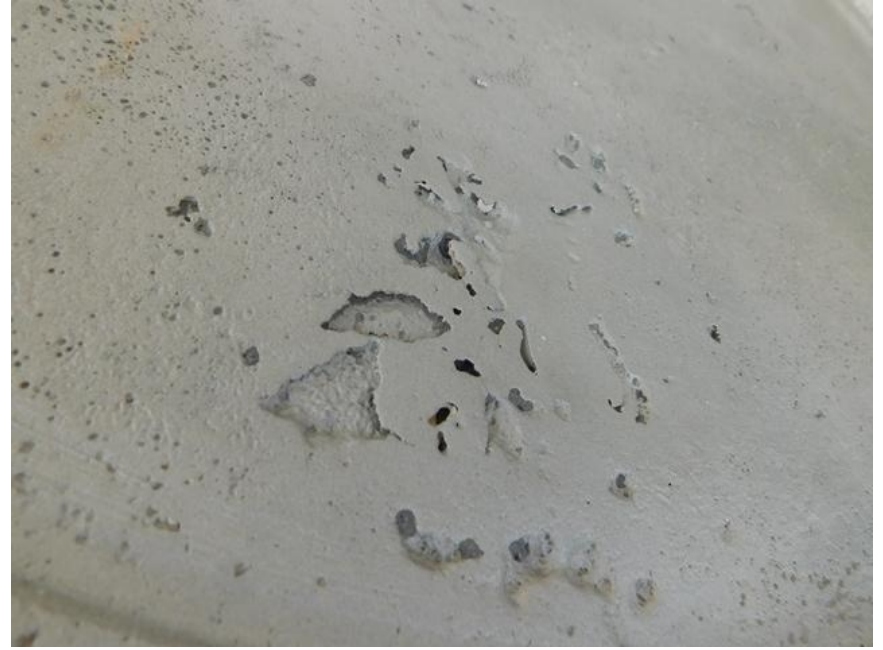
First coat CeramAlloy CL+AC

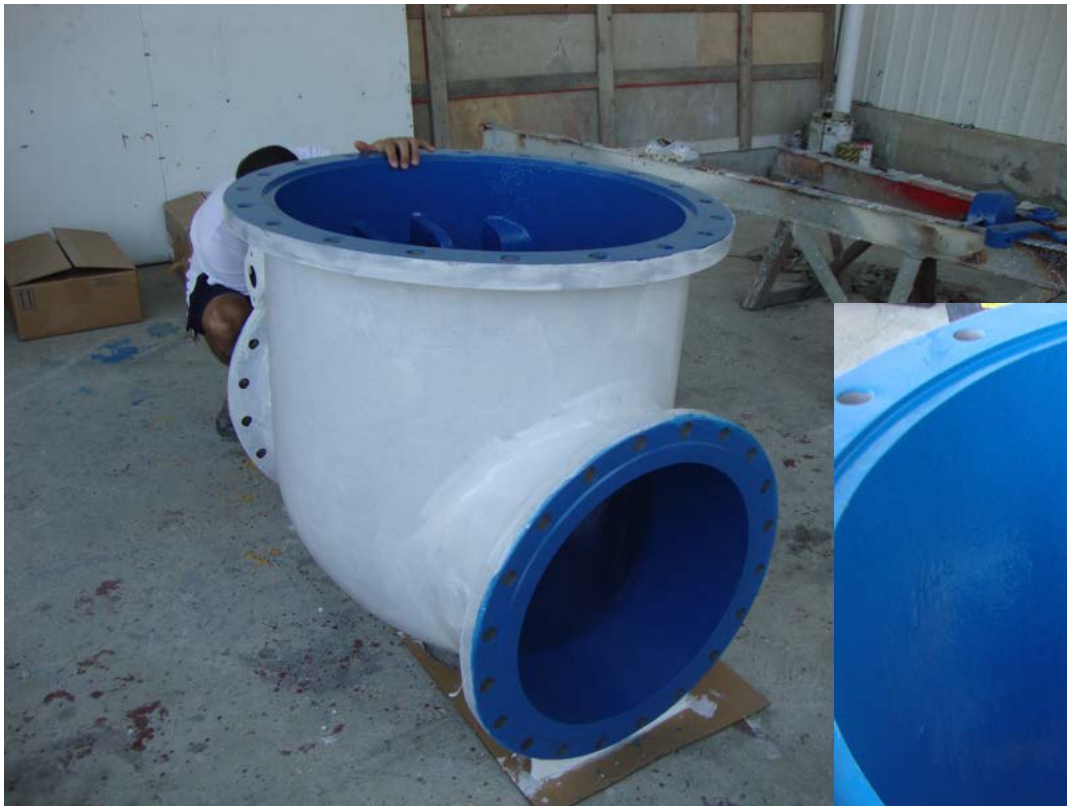
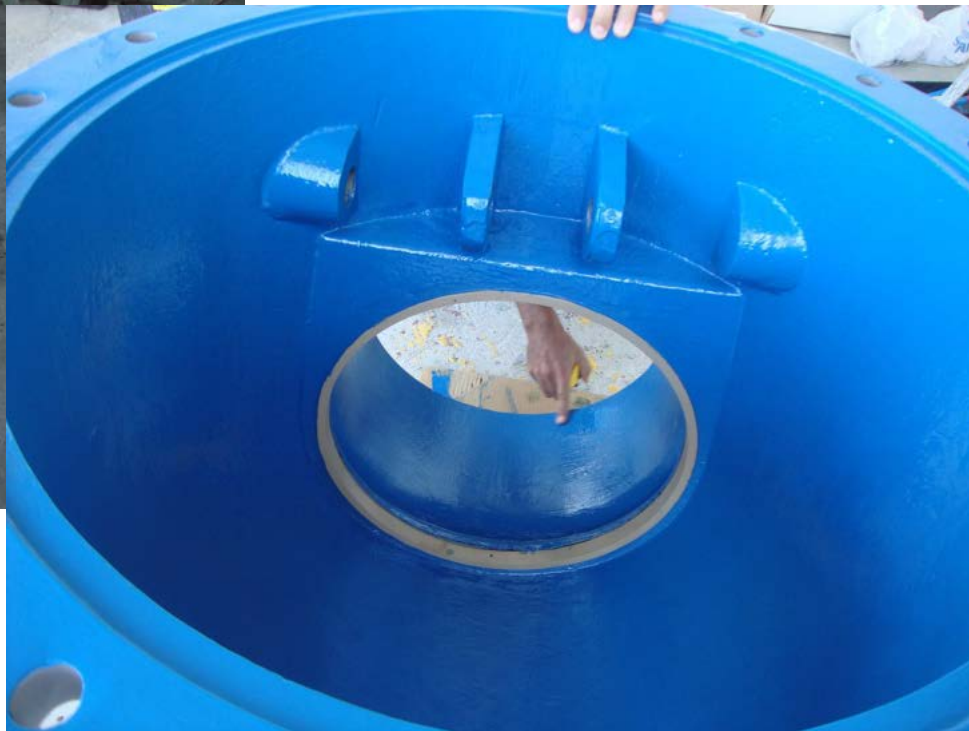
Second coat CeramAlloy CL+AC  
+ CHEMCLAD SC

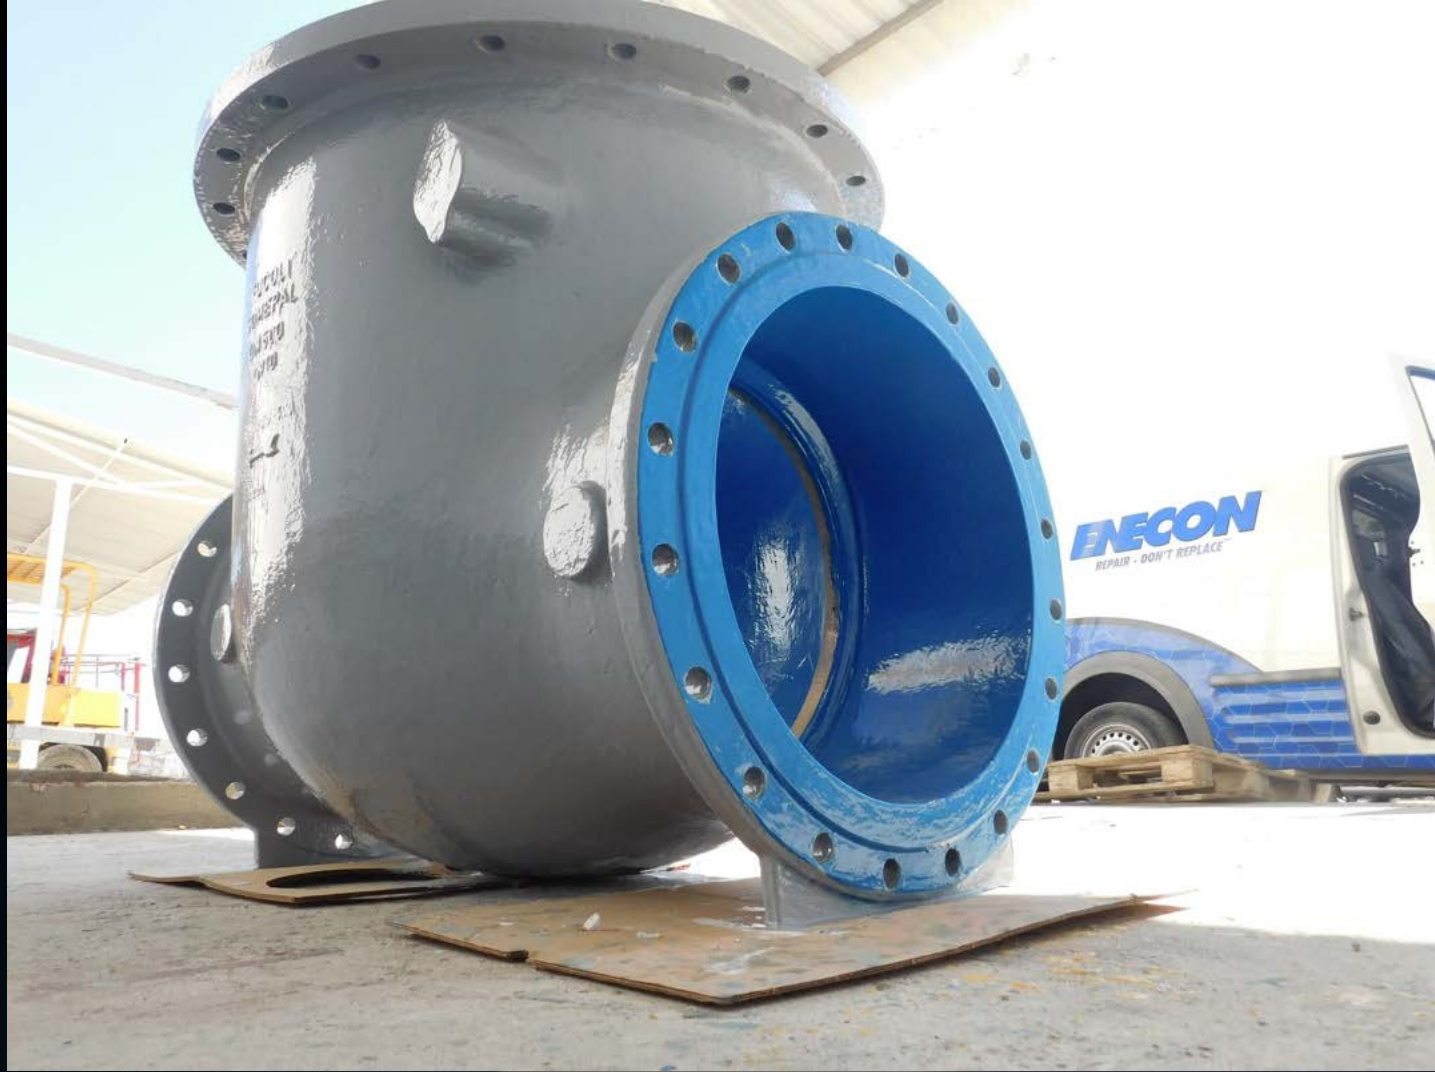
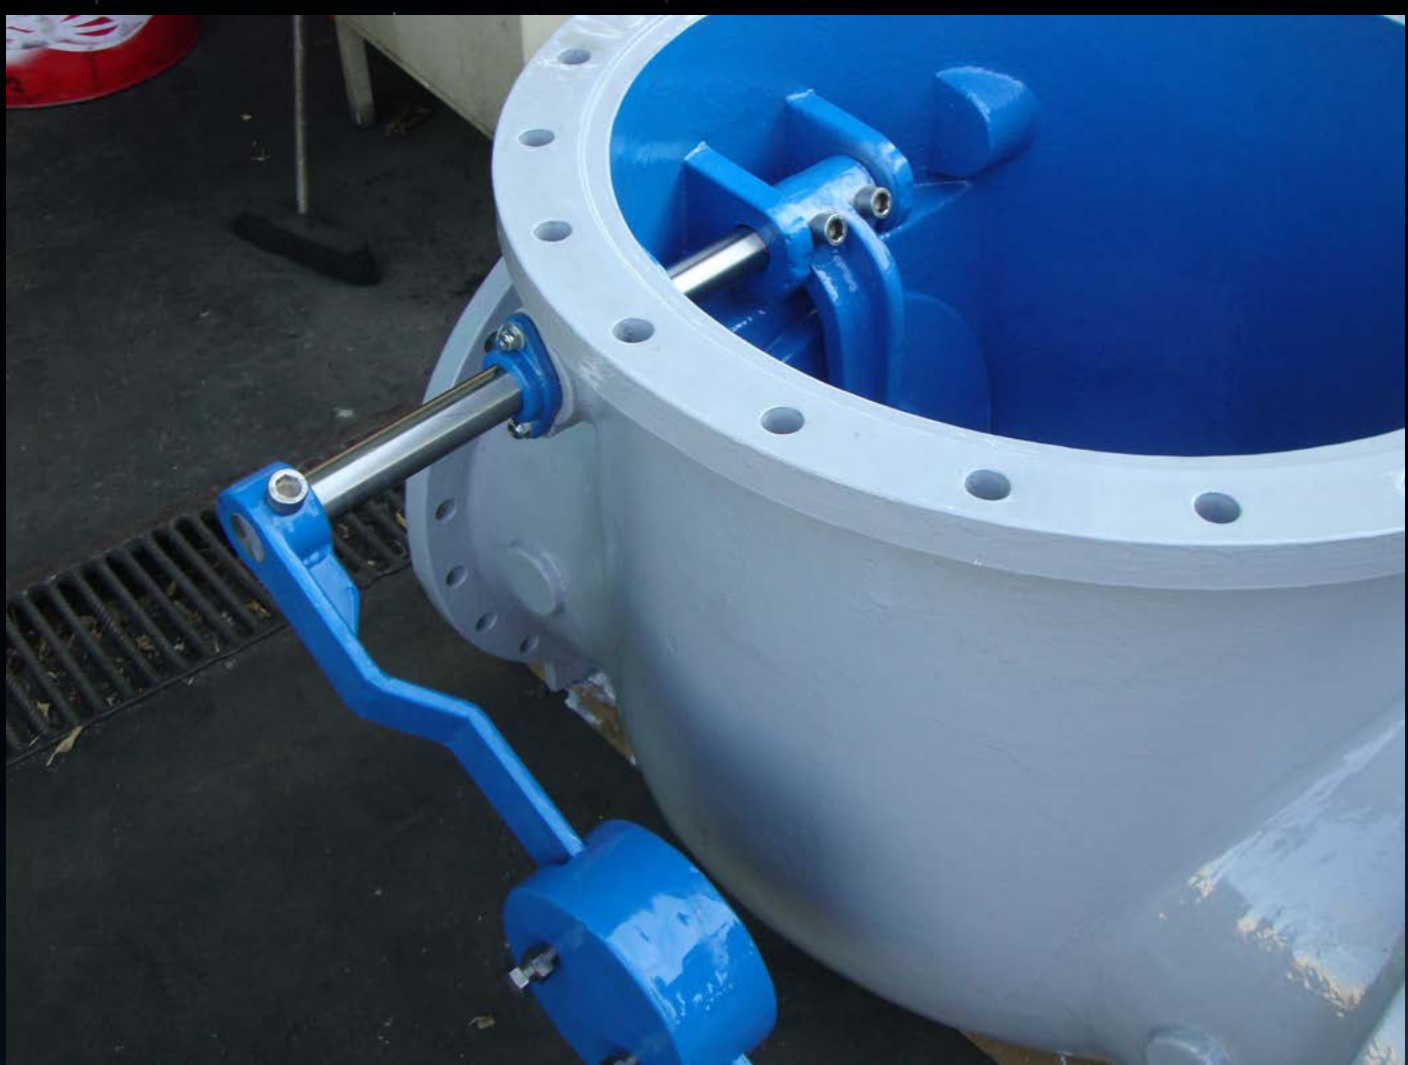
Internal area was coated with minimum 600 microns CeramAlloy CL+AC  
Outside surface with minimum 350 microns CHEMCLAD SC
