## PROJECT REPORT

**PROJECT:** HDPE Geomembranes tank liners' Repairs

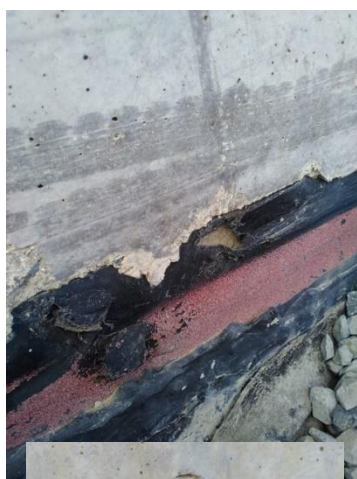
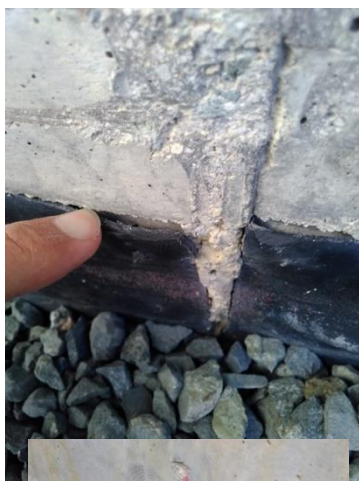
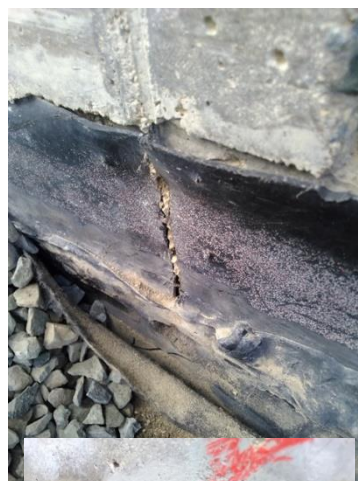
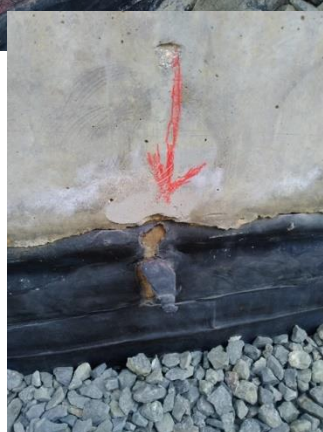
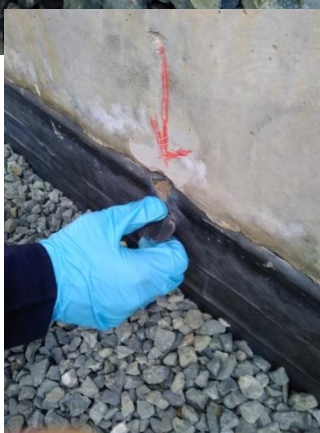
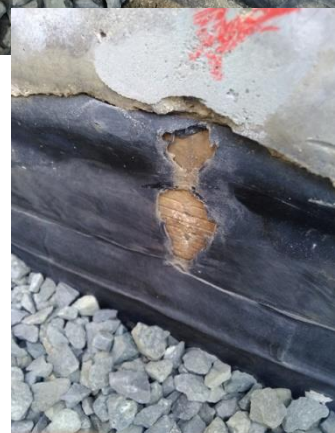
Below we provide some photos taken on site indicating the degree of the problem with the HDPE Geomembrane liners. Due to the sensitivity of the environment, a cold work method was preferred rather than introducing hot works.

- Pulling back cloth material and loose gravel (where required) to have enough space to properly work.
- Cleaning damaged areas from dust, salt and loose membrane parts.
- Using mainly clean cloths and acetone.
- Using sand paper to roughen areas.
- Mixing and applying FLEXICLAD ER on a surface and building it to the desired thickness.
- Using mesh material where the damage was large in order to bridge over.
- Allowing for cure and inspecting the following day

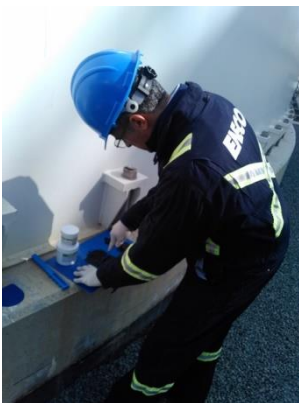
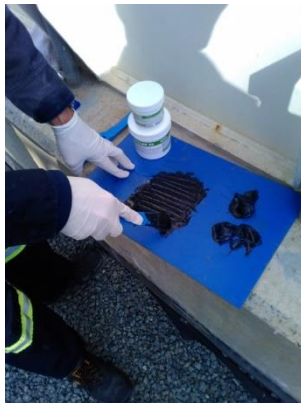
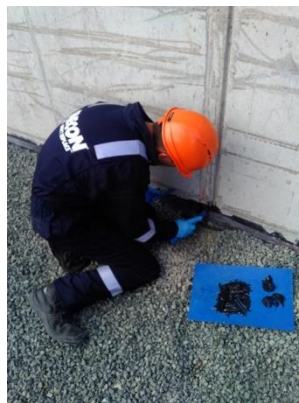
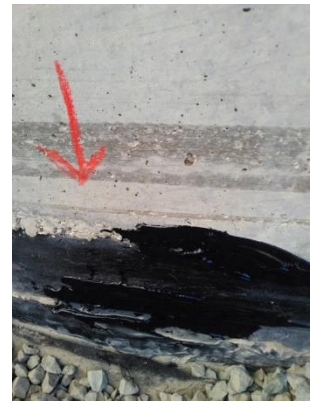
Our company successfully sealed all the damages specified by and agreed with the client. We are in a position to guarantee our repairs for at least seven years. We provided the client with a Completion of Works report.
