Major International Chemical Company Turns to ENECON for Help in Solving Serious Corrosion Issues

This 20-year-old preheater located at a soda ash manufacturing plant in India had been suffering from severe chemical attack and erosion damage.

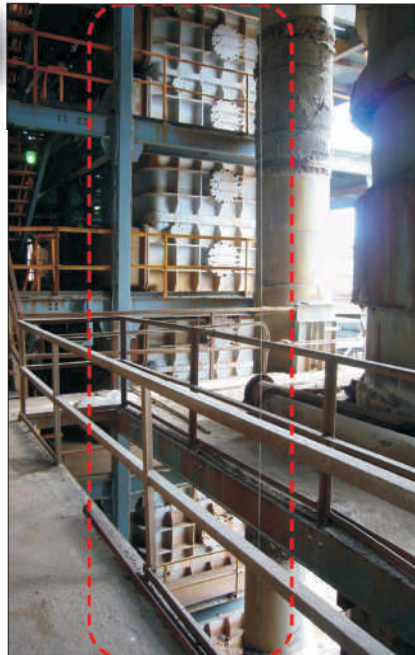
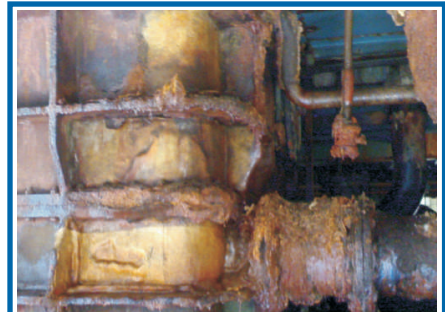
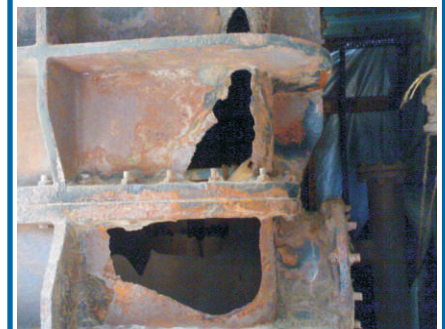
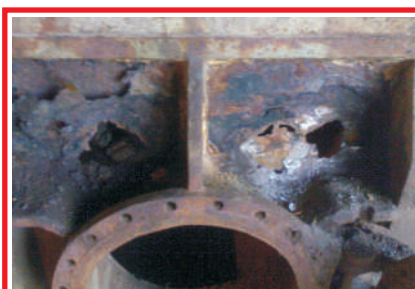
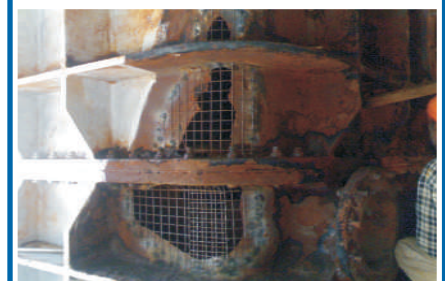
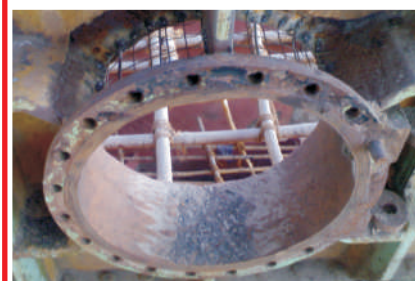
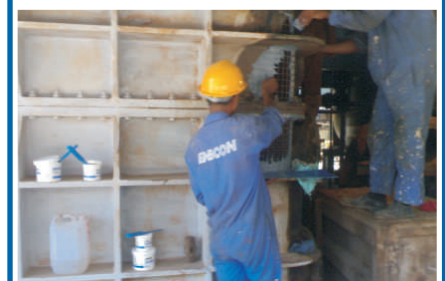
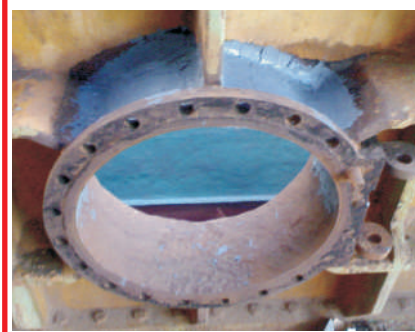
When the surfaces were grit blasted, large holes in the steel were uncovered and these had to be repaired immediately. Welding was not possible due to the potential for further damage to the thin metal surfaces. The ENECON field engineers, therefore, recommended an unconventional repair procedure: stainless steel wire mesh was used to bridge the large holes in the steelwork and **DurAlloy** (224 kg.) was used to permanently repair these areas.

After all holes were repaired, 2 coats of **ENESEAL CR** (280 kg.) were used to protect all of the exterior surfaces from the aggressive environment at this facility.
