## COATACON Inc. & ENECON Alberta Application Case Study

September 2015 - ENECON's ENESEAL CR & HR repairs and protects leaking roof for a Calgary based Sandblasting & Paint Company

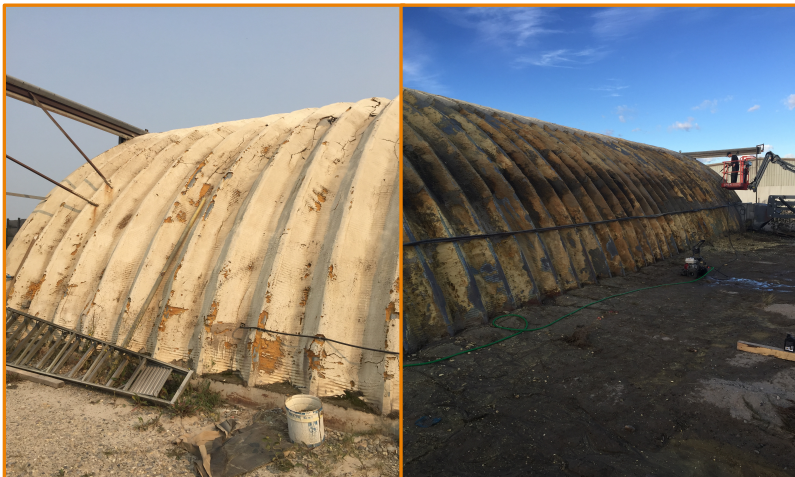
As you can see from the pictures, one of the buildings has a foam insulation layer applied to the exterior. Over time this has eroded, allowing corrosion damage to the metal substrate, which in turn has created a number leaks

Coatacon and ENECON Alberta suggested an alternative solution, which did not require the removal of the insulation – using a combination of ENECON's ENESEAL CR and HR

elastomeric polymer coatings, the only surface preparation required was to pressure wash the roof, removing any loose parts of insulation, rust and dirt

Fiber cloth soaked in ENESEAL CR was used to plug all of the major visible holes. Using an airless sprayer, 2 coats of ENESEAL CR were applied to create an elastomeric protection and 1 coat of ENESEAL HR for a heat refractive finish.
